# **How to Avoid Small Area Stains AND BLEMISHES**

**in the Design, Installation  
and Use of Indiana Limestone**

**INDIANA LIMESTONE INSTITUTE  
OF AMERICA, INC.**

**2ND EDITION**

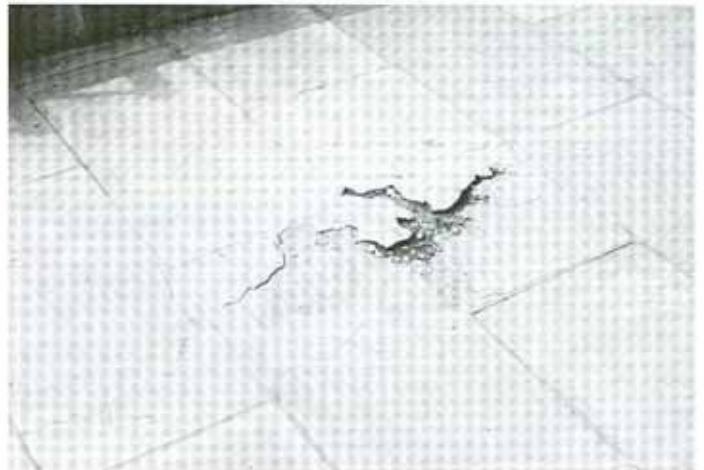
*Over relatively few years, a snow-removal program using salt produced this deterioration on walkway paving.*

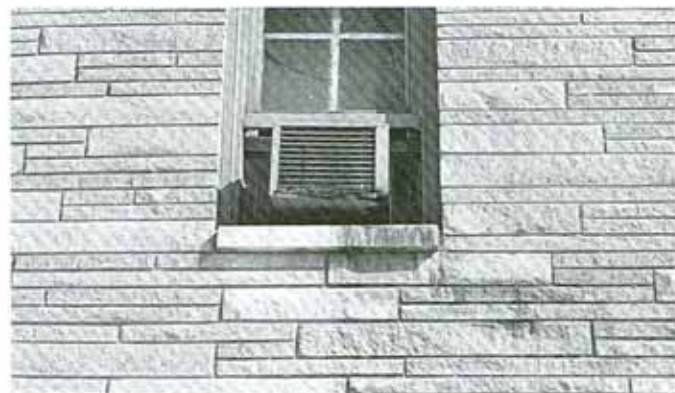
*Lack of maintenance on this air conditioner has produced a badly stained sill and other stones in the splitface wall below.*
